THE DESIGN OF ROTUNDA FALL PROTECTION

The Alexander Hamilton U.S. Custom House in New York City

BY DOUGLAS EMILIO

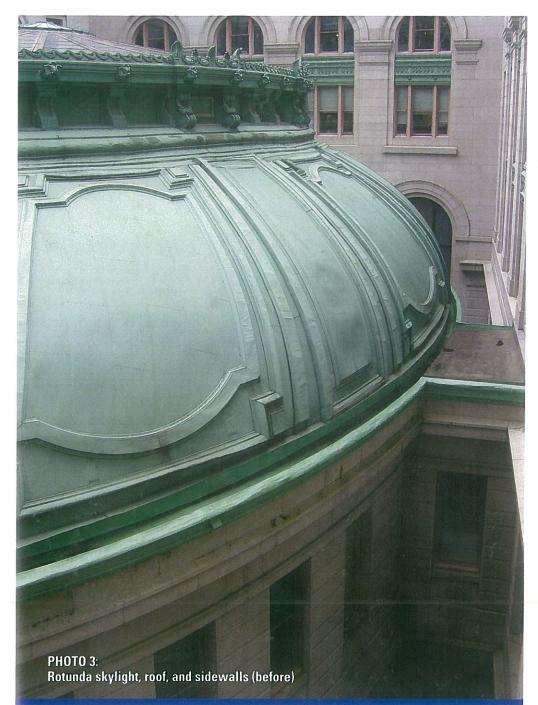
The plan of the building is trapezoidal with the east and west elevations tapering to the streets of Lower Manhattan and Bowling Green Park to the north. In the center of the trapezoid is a central, oval rotunda with corridors that connect the main building block (photos 2 and 3). The interior of the rotunda is 135 feet by 85 feet by 40 feet in height and is constructed using Guastavino tile. The curved interior rotunda ceiling, adjacent to its laylight, is decorated with murals depicting ships entering New York harbor by the Works Progress Administrationsponsored artist, Reginald Marsh. The murals are executed in the Social Realism style and are an interesting juxtaposition to the building's Beaux-Arts style. Above the laylight is an interstitial space for an access walkway, mechanical equipment (including a smoke-purge system), and a sloped aluminum-framed skylight above. The interstitial space includes steel

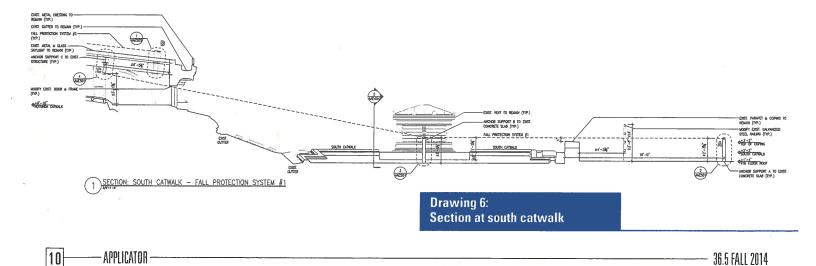
The selected scheme provides access from an adjacent third-floor low-slope roof with an existing metal guard rail, across a barrel-shaped roof and around a rectangular vent at the mid-point (photos 4 and 5), into the interstitial space, and up from the barrel roof to the top of the skylight. The design included three separate fall-protection systems (Drawing 6). The first cable

allows a person to transverse from the flat roof across the barrel roof and either enter the interstitial space or transition up a ladder to the top of the skylight (drawing 8 and photo 9). The second line is vertical and parallel with the ladder and the third is along the skylight in a diamond shape. Fall-protection cables were anchored by means of a post connected to the building's substructure (photo 10) or to fins welded to the steel frame. Pull tests were performed during the construction phase to ensure code-compliant anchorage to the substructure below the flat roof and copper dome. All users of the fallprotection system wear a full-body harness with two lanyards allowing positive connections at transitions between cables.

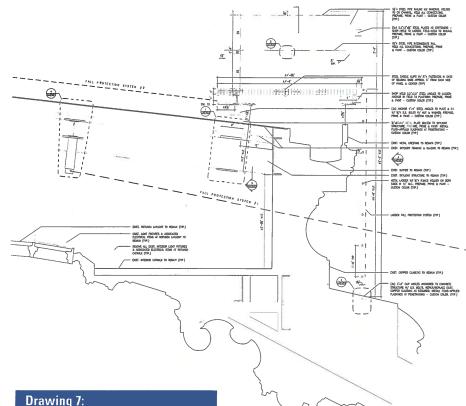
Section of rotunda ladder

Another challenge was designing a ladder from the barrel roof to the top of the skylight. The new custom ladder, platform, and railing assembly had to have the smallest footprint possible, and would need to transition over the existing built-in gutter. In addition, the inner edge of the platform was located over the skylight, limiting mounting/ support points. For this condition, the ladder itself was designed to be structural, supporting the outer portion of the platform. The inside edge of the platform was supported by a single steel fin that passed through the skylight frame and attached to the steel frame below, a more robust version of the skylight fall-protection

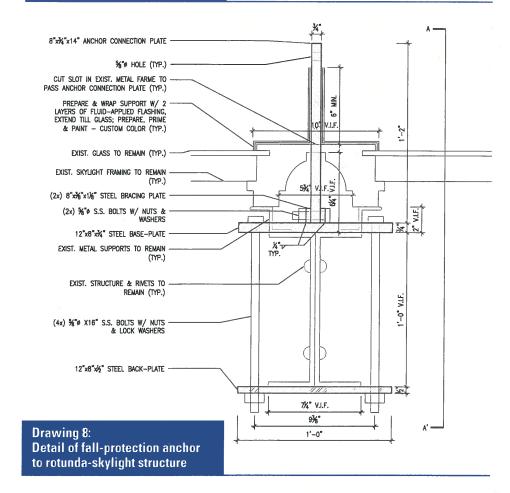
One of the design challenges was how to connect the fall-protection system to the steel frame below the skylight and have it pass through the skylight. The ultimate design called for cutting a slot for a $\frac{3}{4}$ "-metal fin in the skylight frame at selected locations (photo 11). The fin was then bolted to an upper steel receiver located on the top of the existing steel frame and then connected to a lower welded-steel angle. The two were then connected with threaded rods (photo 12).

Douglas Emilio is an associate partner at the architecture and engineering firm of WASA/Studio A in New York City. He has led complex adaptivereuse and exterior-envelope projects for public and private clients. He is adept at master-plan development and largescale conditions assessments, as well as fine-grained preservation, conservation, and exterior-envelope projects.• PHOTO 11: Detail of fall-protection anchor to rotundaskylight structure

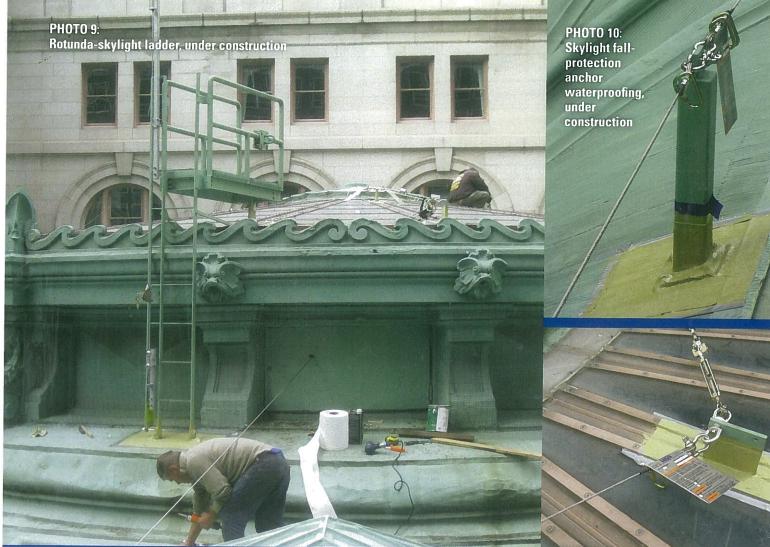
anchor points. To waterproof the slotted connection through the skylight, ladder legs, and cable posts, we used a PMMA fluid-applied flashing system with a reinforcing fleece. A final color coat of the flashing membrane allowed the waterproofing to match the color of the existing aluminum skylight frame and copper-clad roofing, further minimizing the impact of the new elements.
